In this case, our customer's environment was hot, dirty and the application called for frequent start and stop cycles. These conditions led to excessive heat in the rotor of their 3500 HP medium voltage motor.

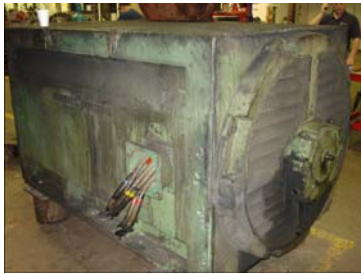
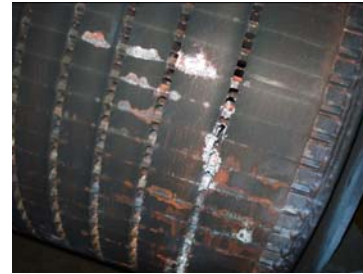
Arriving on site in response to an emergency service request, Kiemle-Hankins technicians quickly identified a potential source of concern. Arching was witnessed during starting and operation of the motor. In addition to the arching, there was debris near the motor and in the process area. Our technicians recommended immediately removing the motor from service to prevent a potential catastrophic failure. The customer complied and Kiemle-Hankins transported the motor to our facility.

Upon disassembly and inspection, the technician's concerns were validated. The rotor bars had deteriorated to the point that they were disintegrating and pieces of the bars were being expelled into the stator air gap. Had this condition continued, the stator would have suffered severe damage including a potential insulation failure and a short circuit condition. Left unchecked this condition would have quickly turned into a stator rewind.

In typical fashion, KH proceeded to identify possible solutions to their customer's problems. A key motor was out of service and there was a good likelihood that the spare unit would suffer a similar fate. In an effort to provide valuable alternative solutions, KH scoured their contacts in the used motor industry and identified a used alternative. Unfortunately, this option proved to be too costly to be economical for the customer. The next step in our investigation was focused on extending the life of the existing motor. Understanding that the failure was closely tied to the heat experienced in the rotor, a solution presented itself. A plan was devised to replace the current aluminum alloy in the rotor bars with a copper alloy. This substitution would offer increased thermal tolerance and minimize the physical stresses of the rotor bars promoting a longer life. The customer recognized the value of the proposed plan and authorized KH to proceed.
